Manhole Inspection Summary

Manhole # S23A__032MH

Insp Date: **7/27/07 8:21 AM**

Location Address: **702 GILMORE ST**

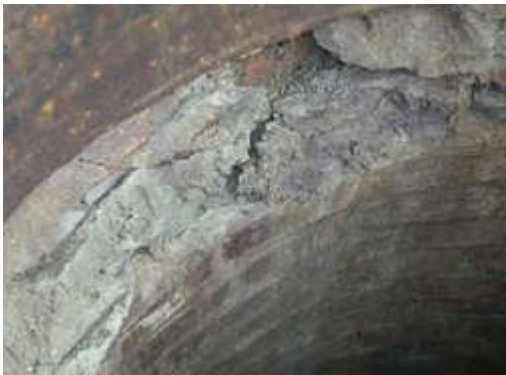
Defect 2

Condition: ☐ Sound ☐ Cracked ☐ Root Intrusion ☐ Loose Brick ☒ **Deteriorated**

MAJOR DETERIORATION OF CHIMNEY

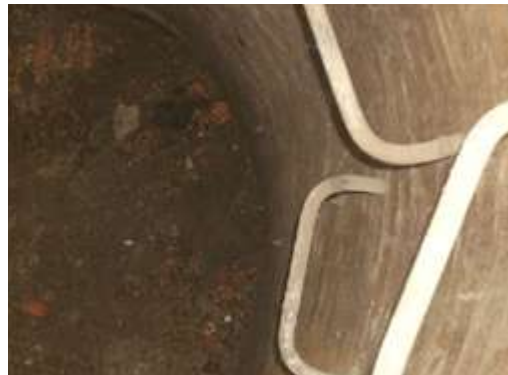
Defect 1

Count: **3** Missing: **3** ☐ Corroded

MISSING STEPS

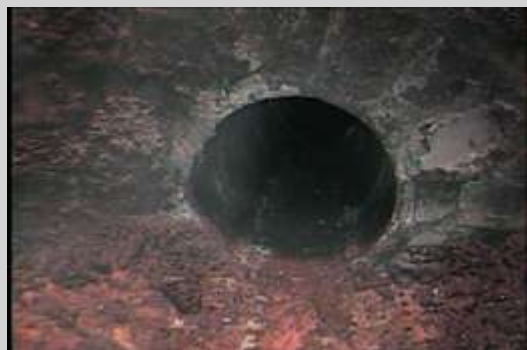
12 O'Clock Outflow

8 in. Circular Gravity Sewer
Pipe Out @ 12 O'Clock

Infiltration: **None** Pipe Seal Cond: **Sound**
